Sudden downshift mechanism

**NHTSA Sudden Down Shift Investigation
BGFA-1018720 Low Temperature**

**BGFA-1018818 Sudden Down Shift Investigation
Low Temperature Mode**

**B7WA-8014113 Sudden Down Shift Investigation
Low Temperature Mode**

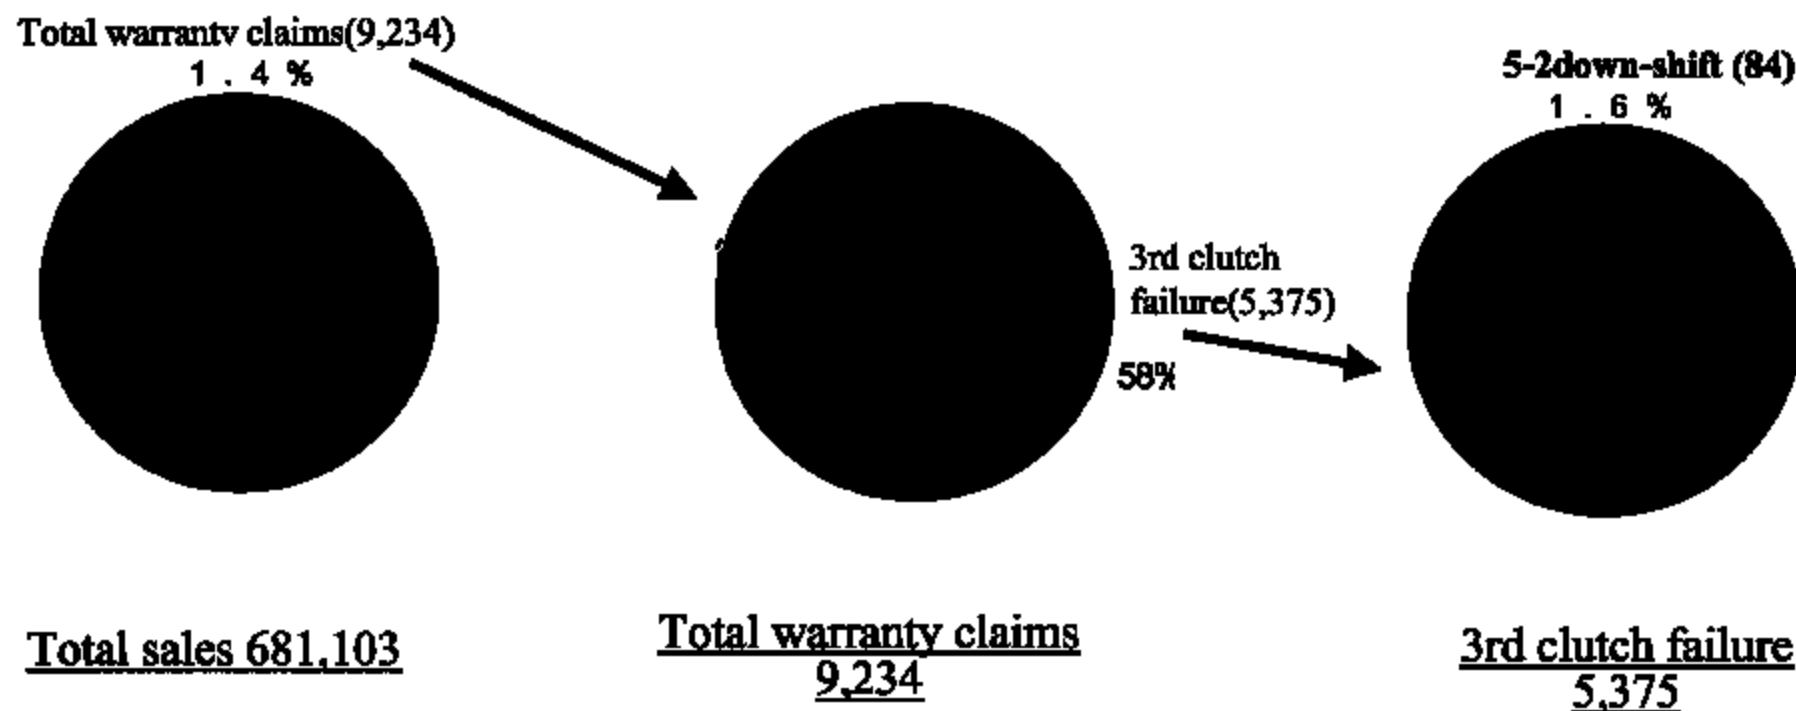
Occurrence ratio

5-2down-shift occurrence ratio=84/681,103=0.01%

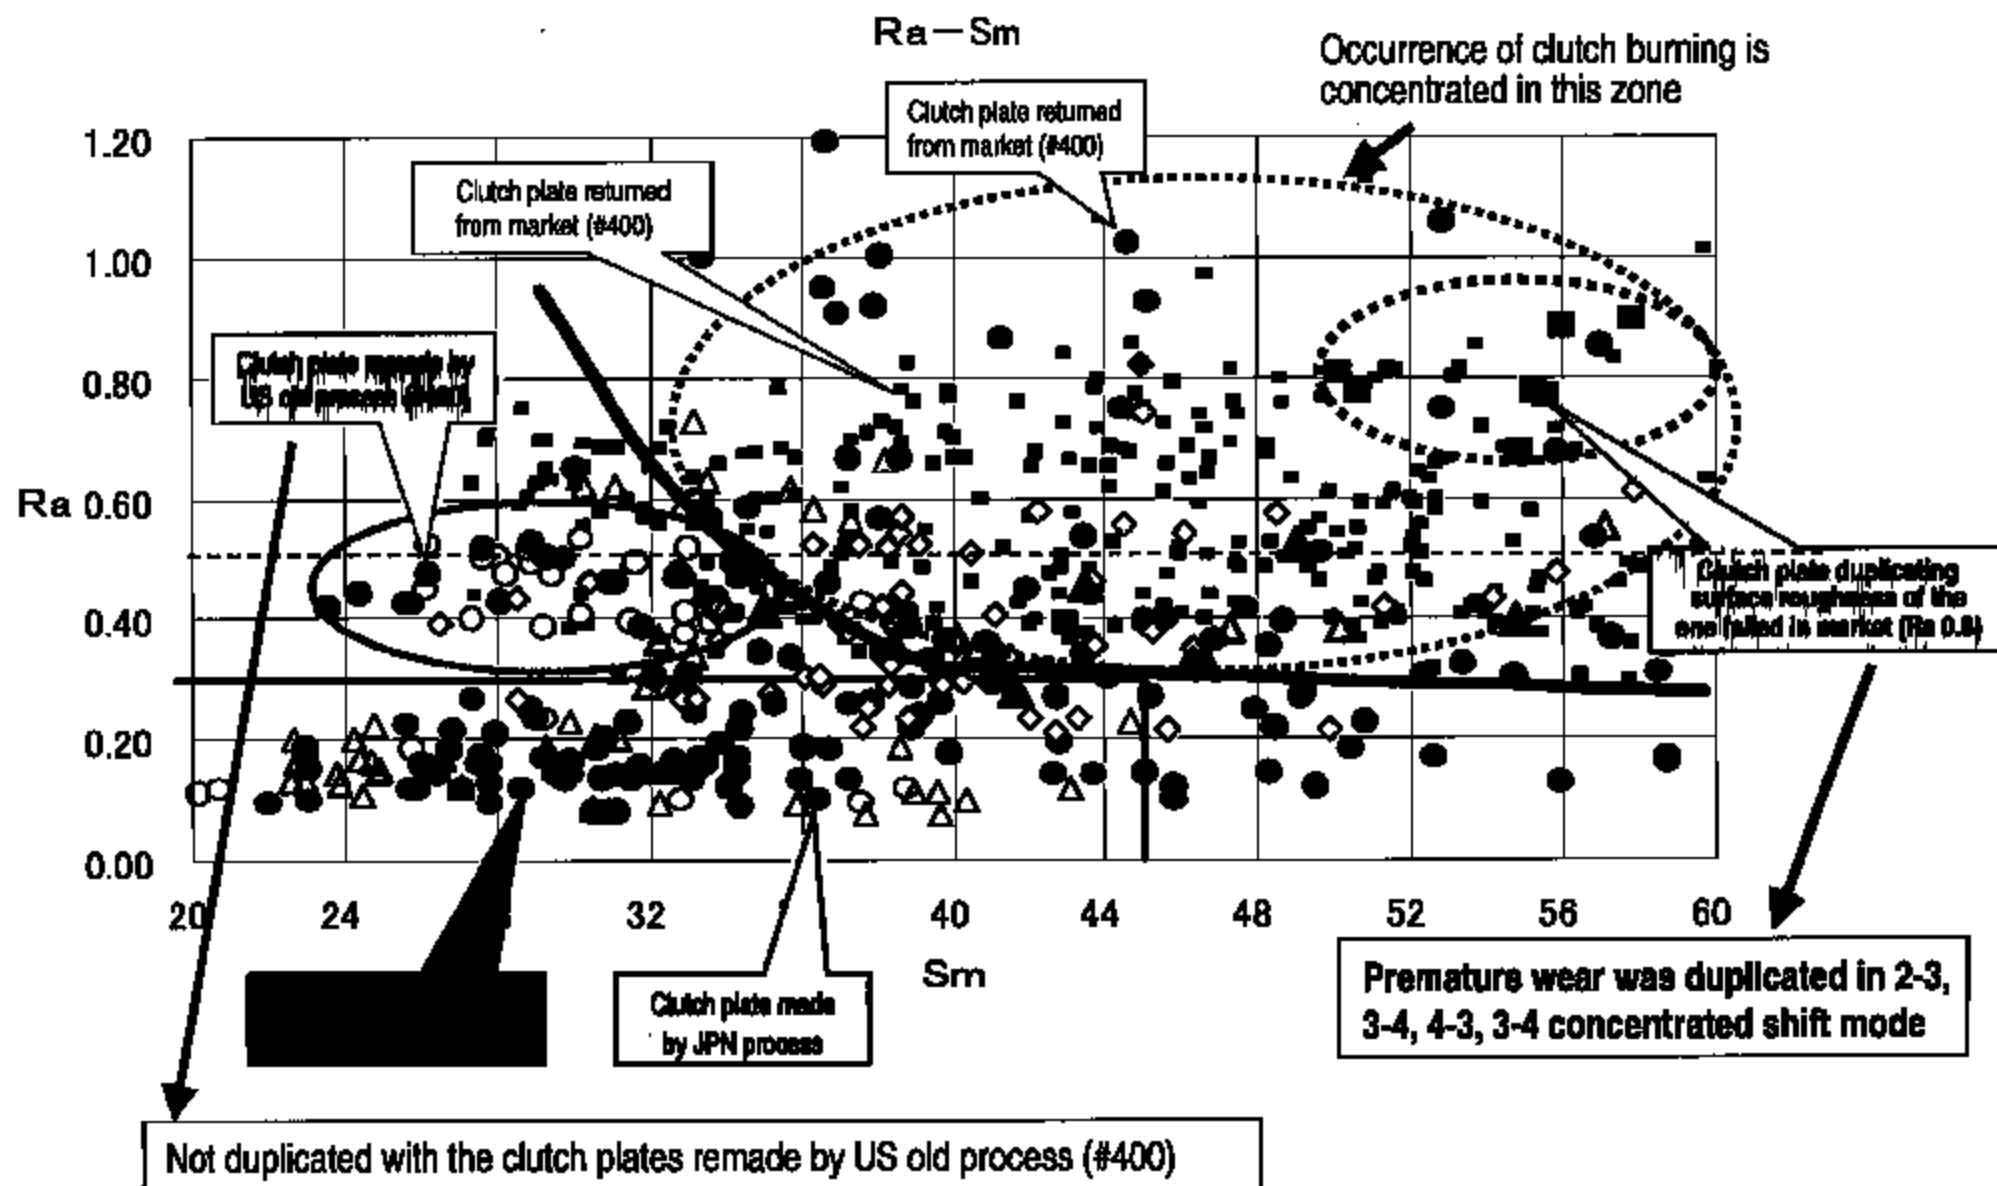
3rd Clutch Wear – Summary of Surface Roughness Data as of the End of September

【Causal factor of sharp increase】 Worsening of clutch plate surface roughness level

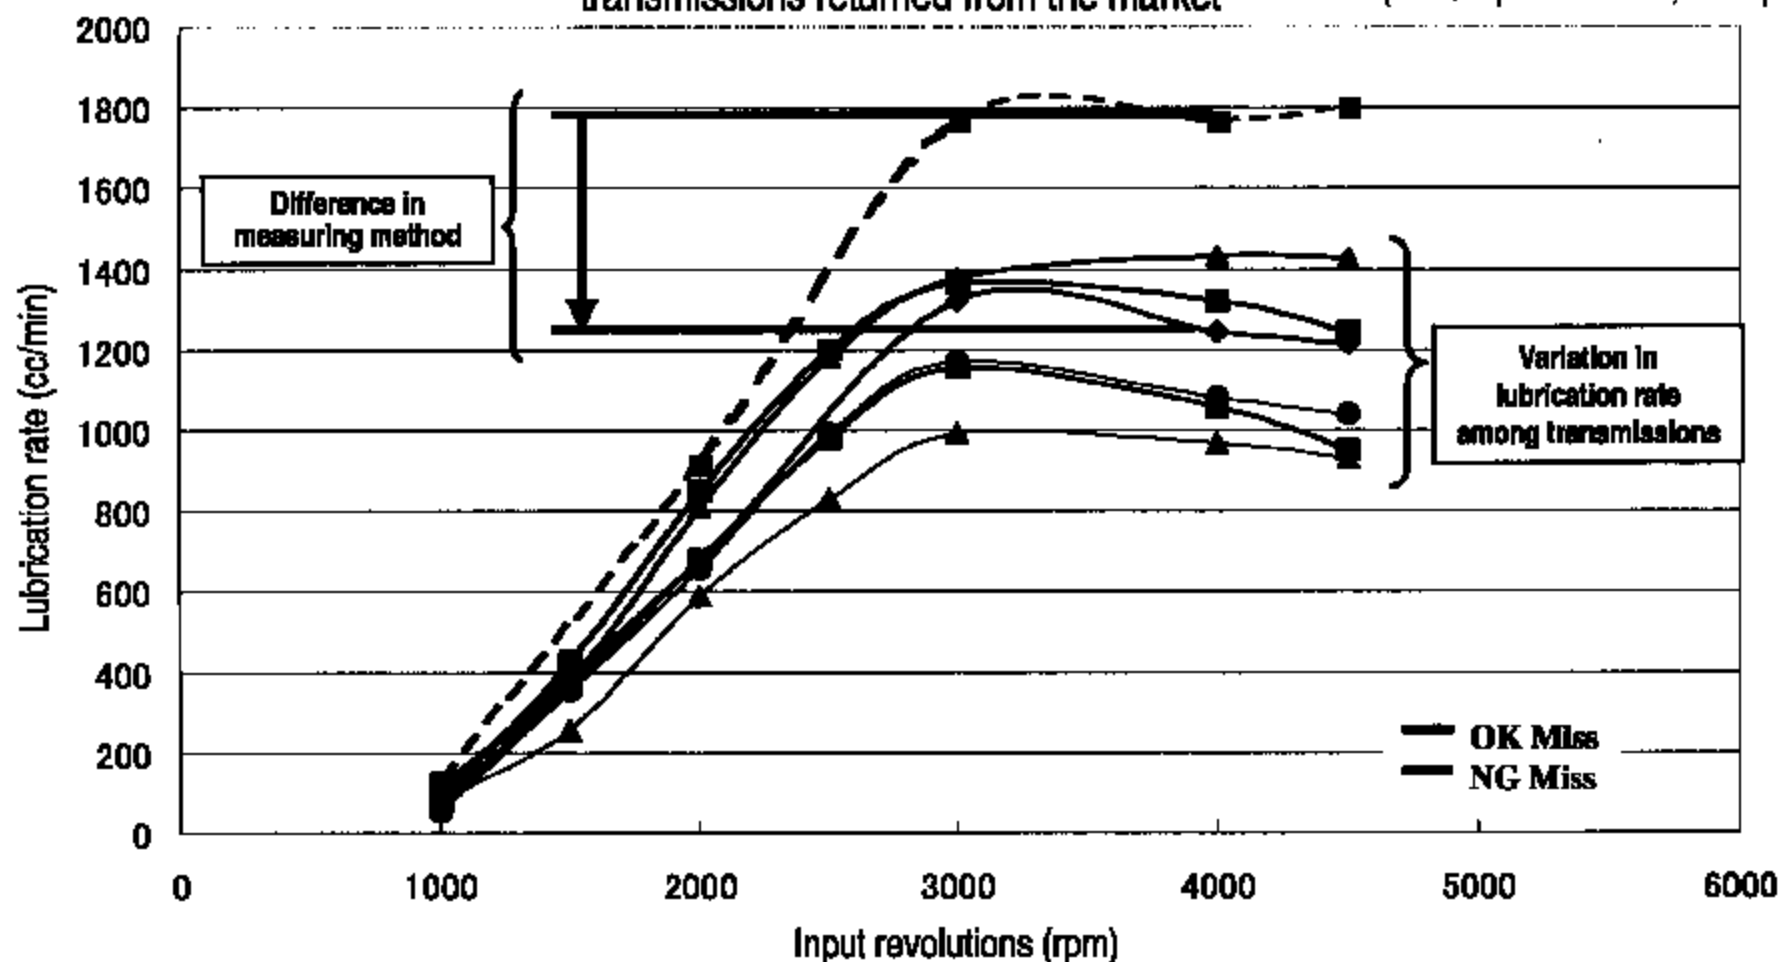
Lubrication Rate of Transmissions Returned from the Market

- Variation in lubrication rate among transmissions was about 475cc/min at 4000rpm.
- There was no difference in change in lubrication rate attendant upon change in rpm between the clutch wear OK transmissions and clutch wear NG transmissions returned from the market.
- When the accuracy of lubrication rate measurement was improved (by making a change to a jig that can better simulate the actual condition), the absolute value of lubrication rate was decreased by 530cc/min (at 4000rpm).

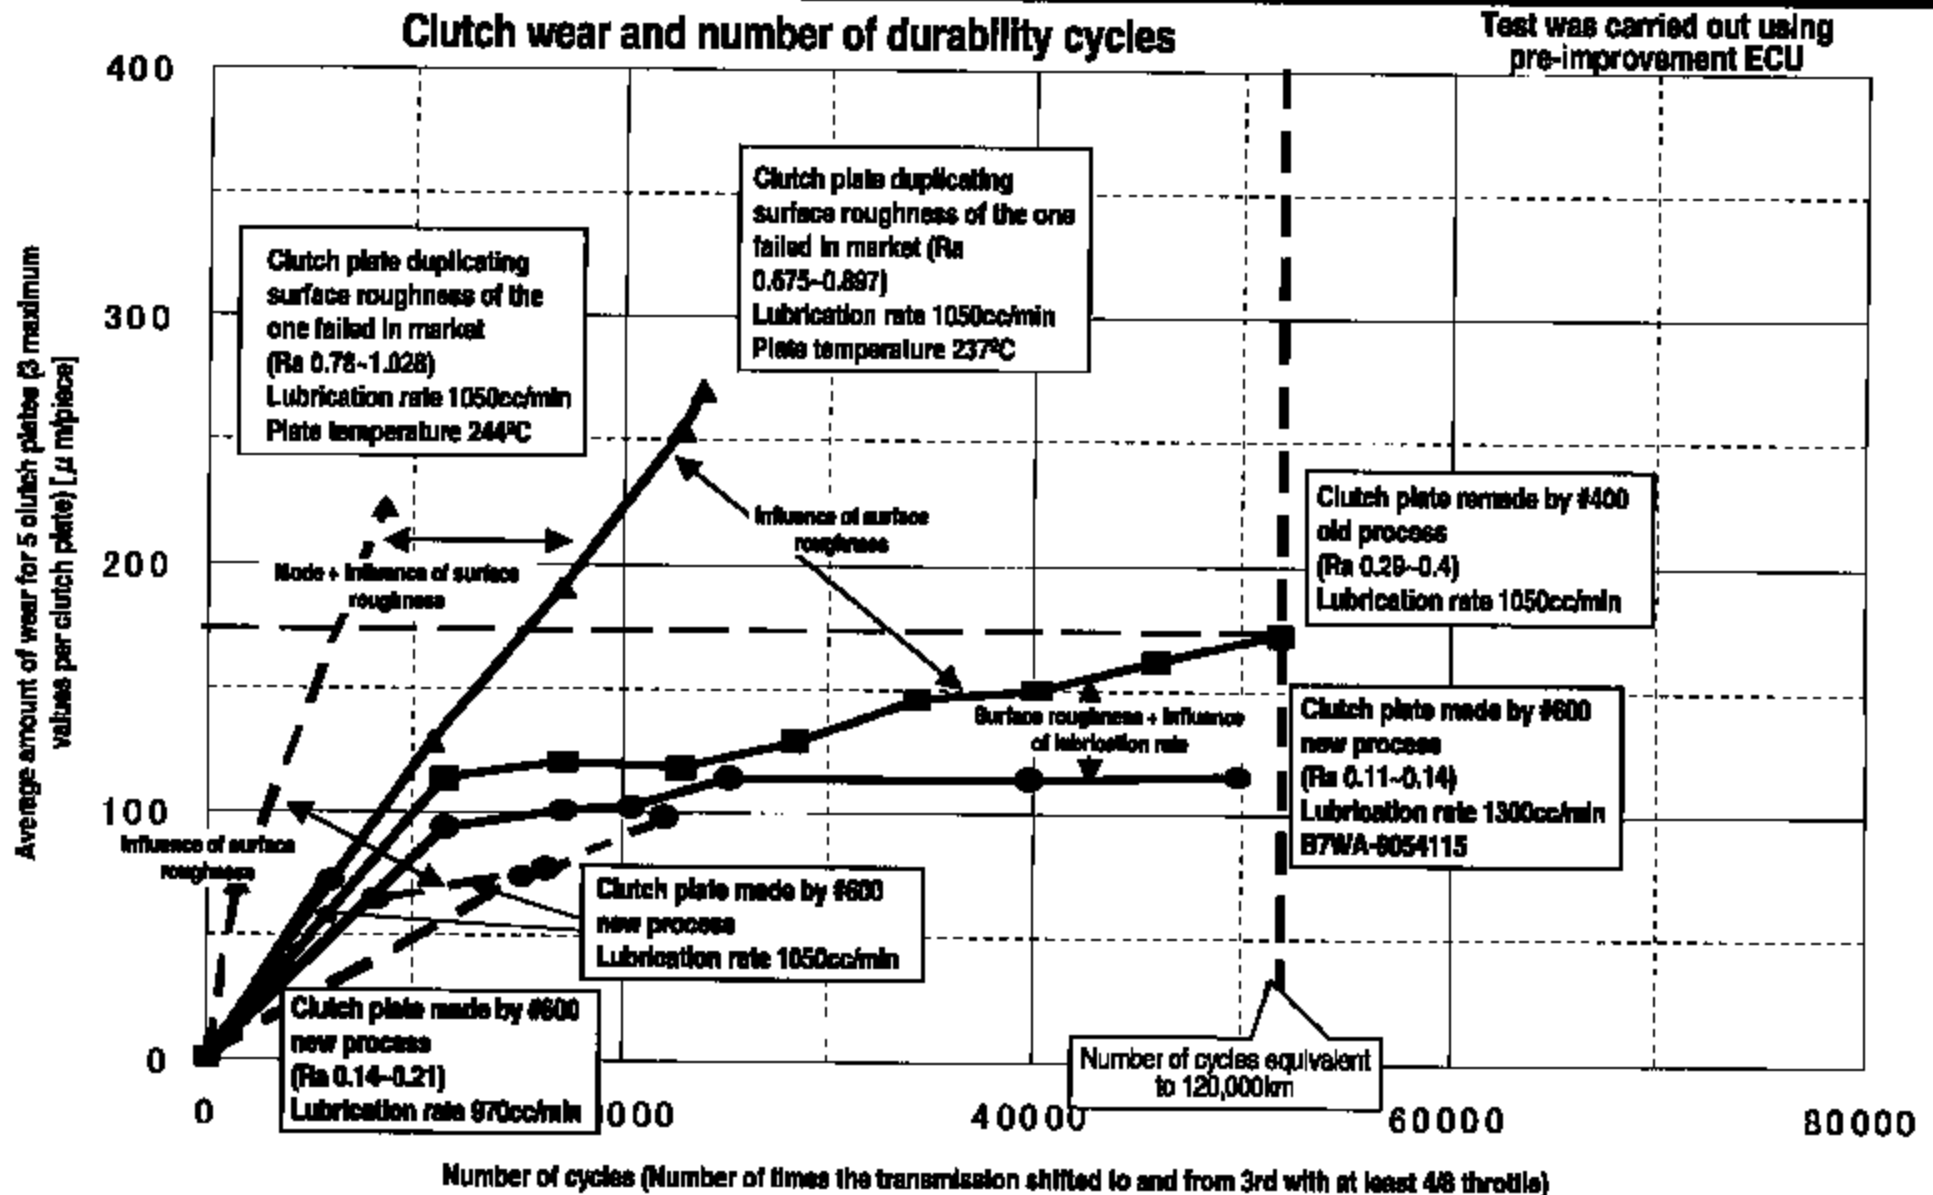
● Premature wear was duplicated

- Surface roughness has a great influence on clutch wear. What influence lubrication rate and ECU have on clutch wear should be clarified.
- The test conducted using clutch plates remade by #400 old process (Ra 0.3-0.4) and the pre-improvement ECU has met with OK result, however, clutch plates and ECU require further verification as to specification lower limit.
